Aercoustics Project #: 05259.00

St Marys Cement Inc. (Canada)CBM Aggregates - Codrington
55 Industrial Street
Toronto, Ontario, Canada
M4G 3W9ATTN: Mike Le Breton, Lands Manager, Eastern Region, CBM
Jillian Werry, Land and Environmental Coordinator, CBMSubject: CBM Aggregates Codrington Pit Acoustical Audit 2025
MNR Licence # 624984
Part of Lots 32-34, Concession 6, Geographic Township of
Brighton, County of Northumberland**1 Introduction**

Codrington Pit 2025
 Acoustical Audit

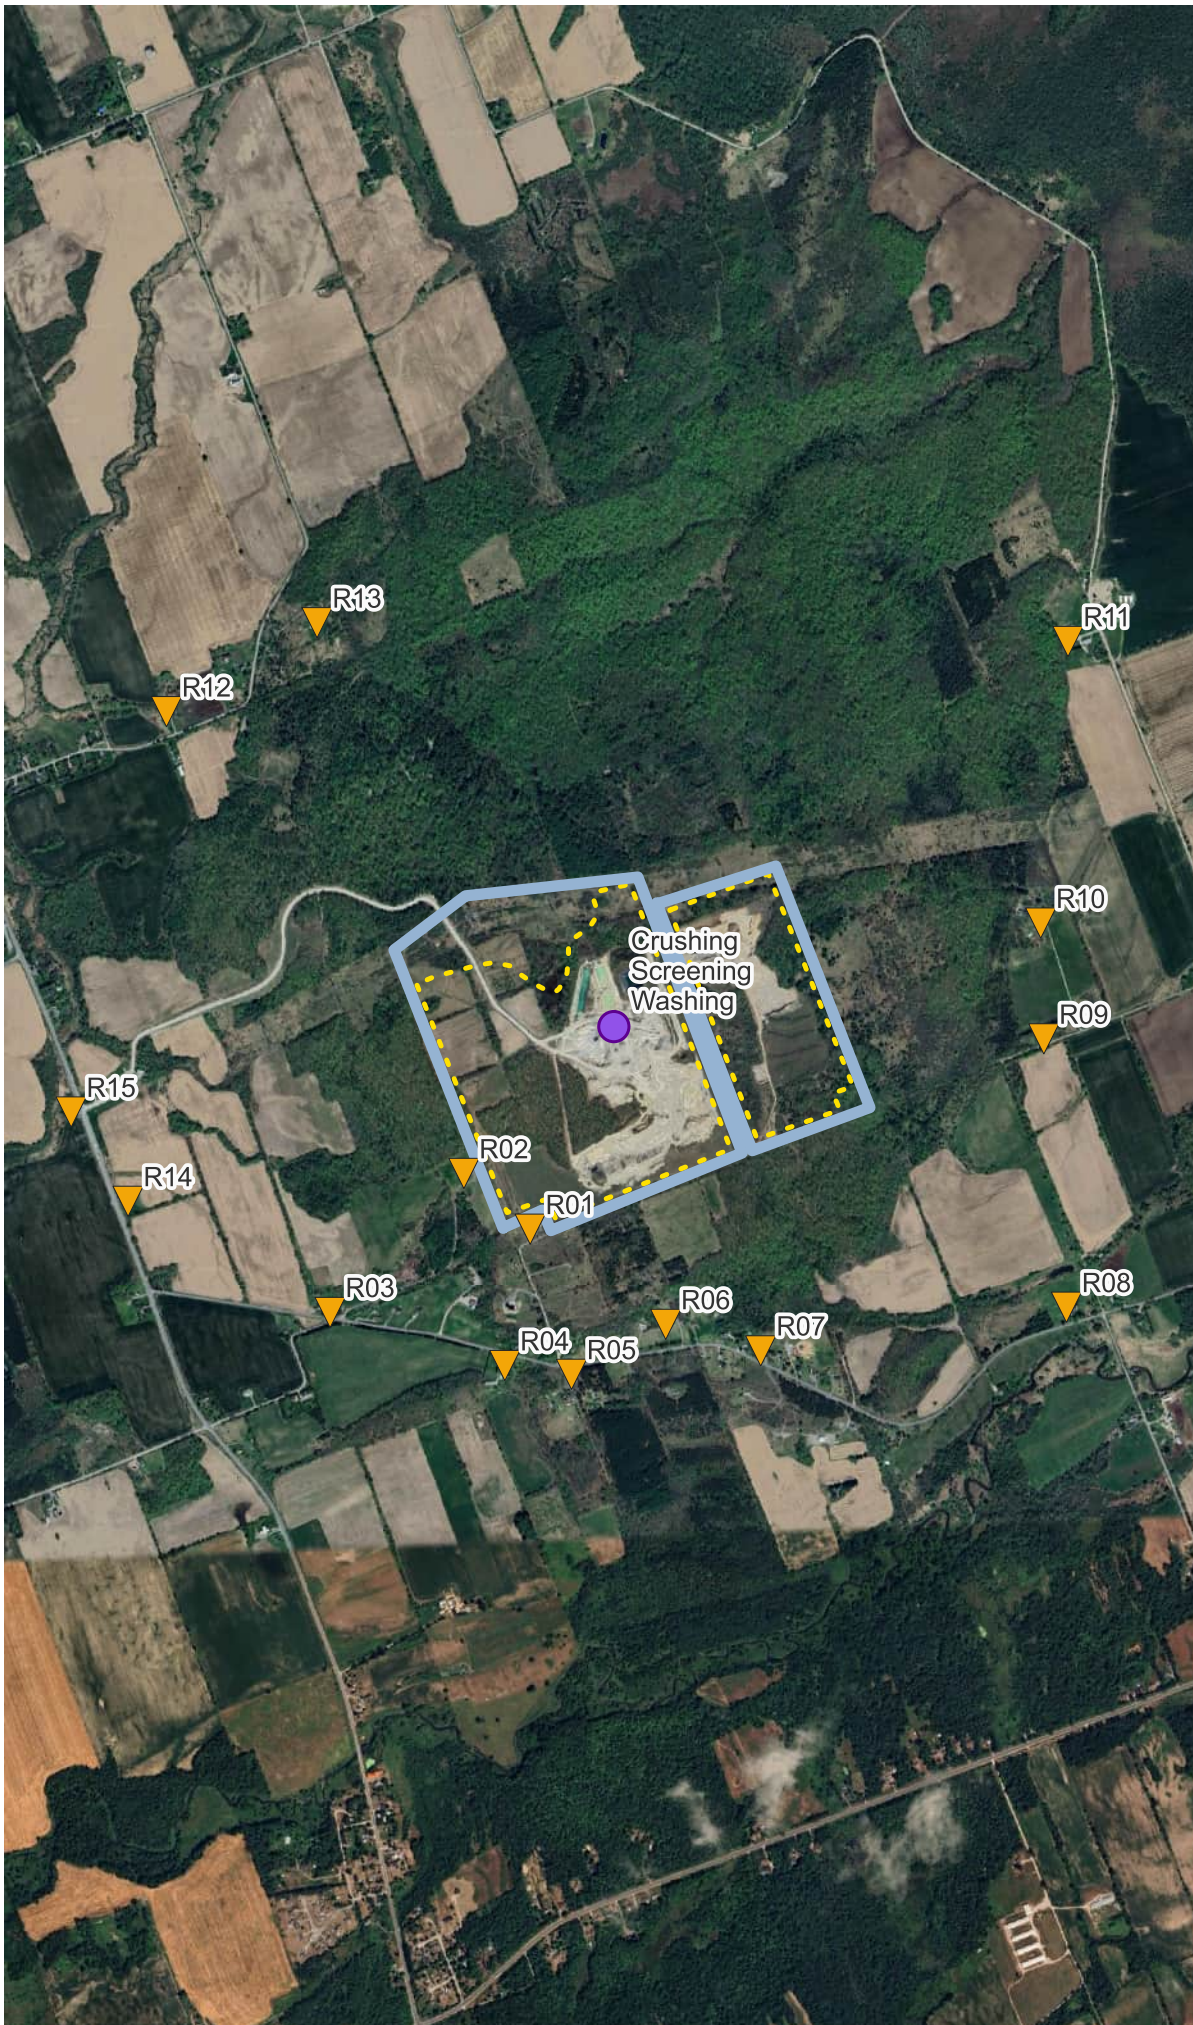
Figure 1

The surrounding receptors and equipment locations are illustrated in Figure 1.

Key Plan Showing Site
 Receptors and Location
