**CODRINGTON PIT  
2016 MONITORING PROGRAM  
REPORT**

Prepared for:  
St. Marys Cement Inc. (Canada)  
55 Industrial Street  
Toronto, Ontario  
M4G 3W9

Project No. 13-005-00

December 8, 2016

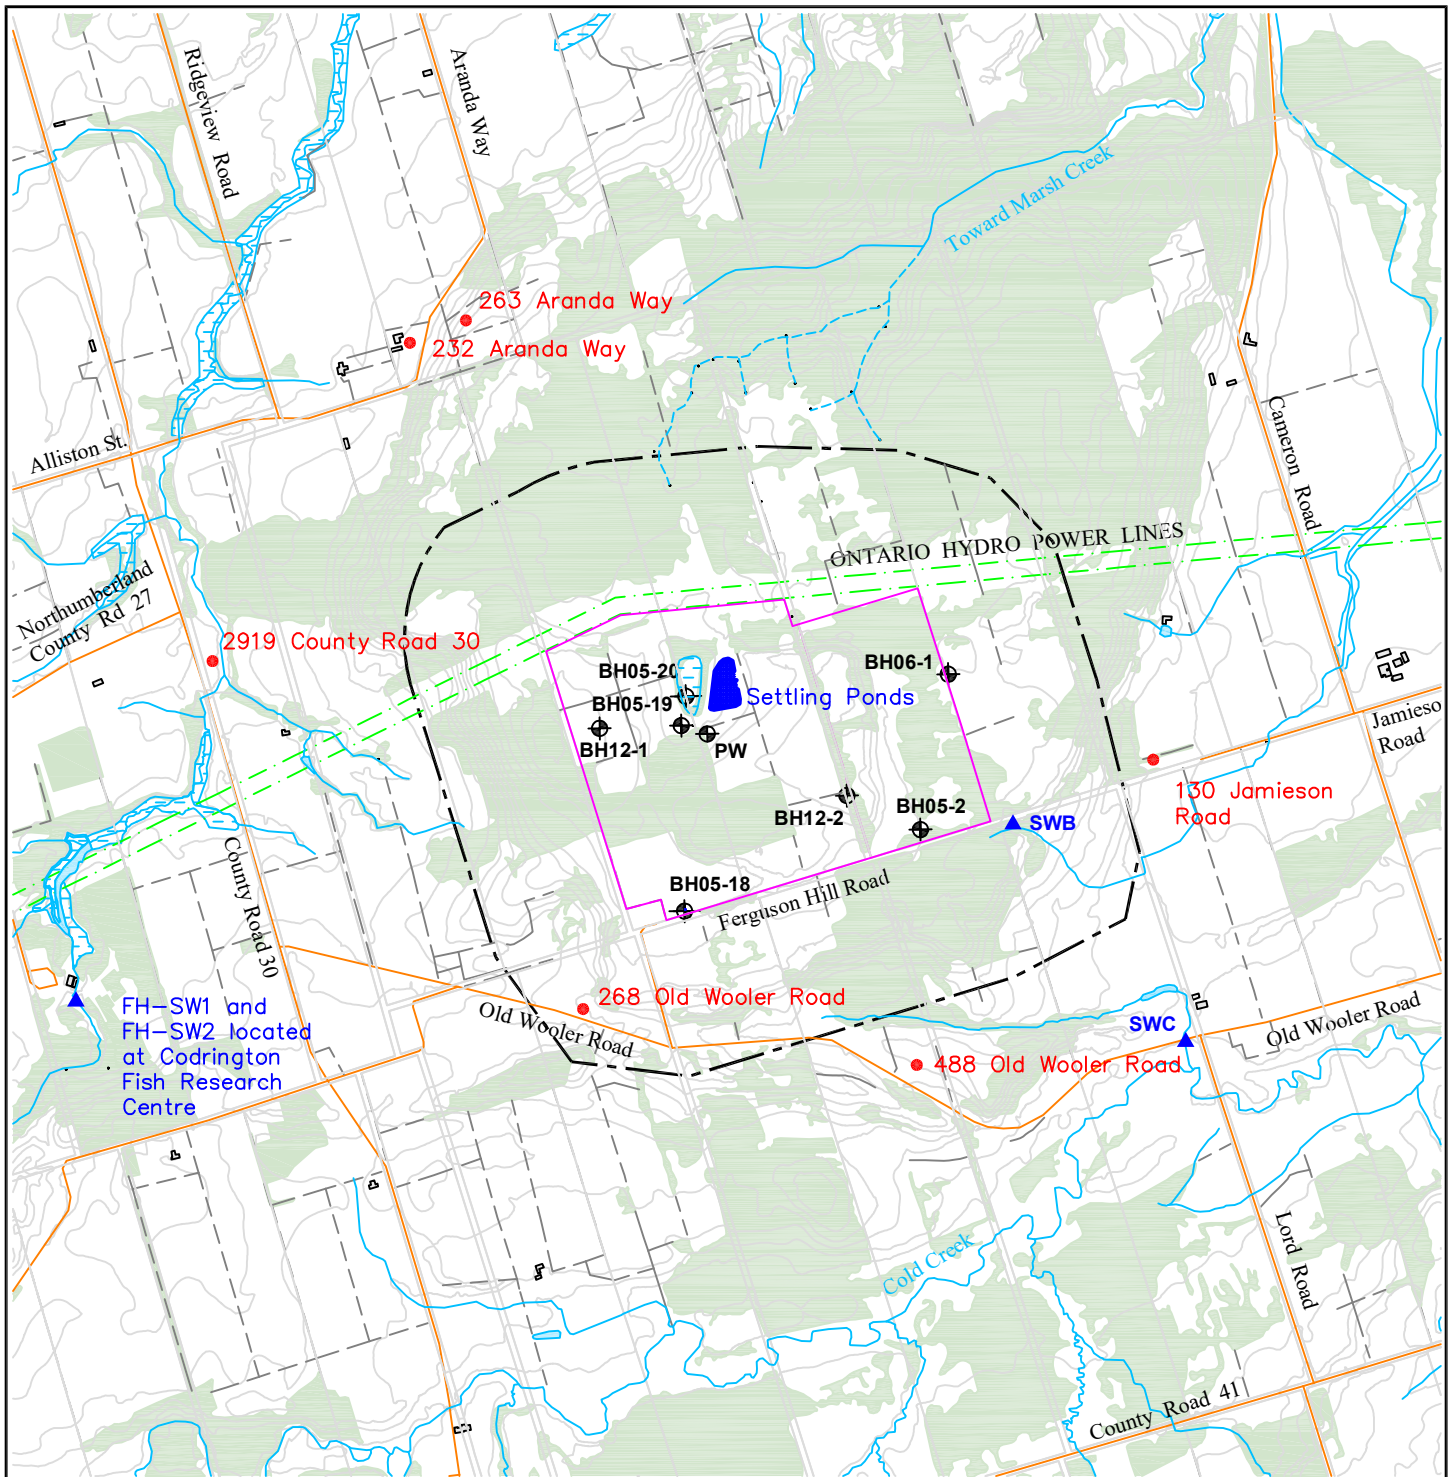
- PIT LOCATION
- BH05-2** MONITORING WELL LOCATION AND DESIGNATION
- 500 m RADIUS FROM THE PIT
- APPROXIMATE LOCATION OF DOMESTIC WATER WELLS
- ▲ **SWB** SURFACE WATER STATION LOCATION AND DESIGNATION

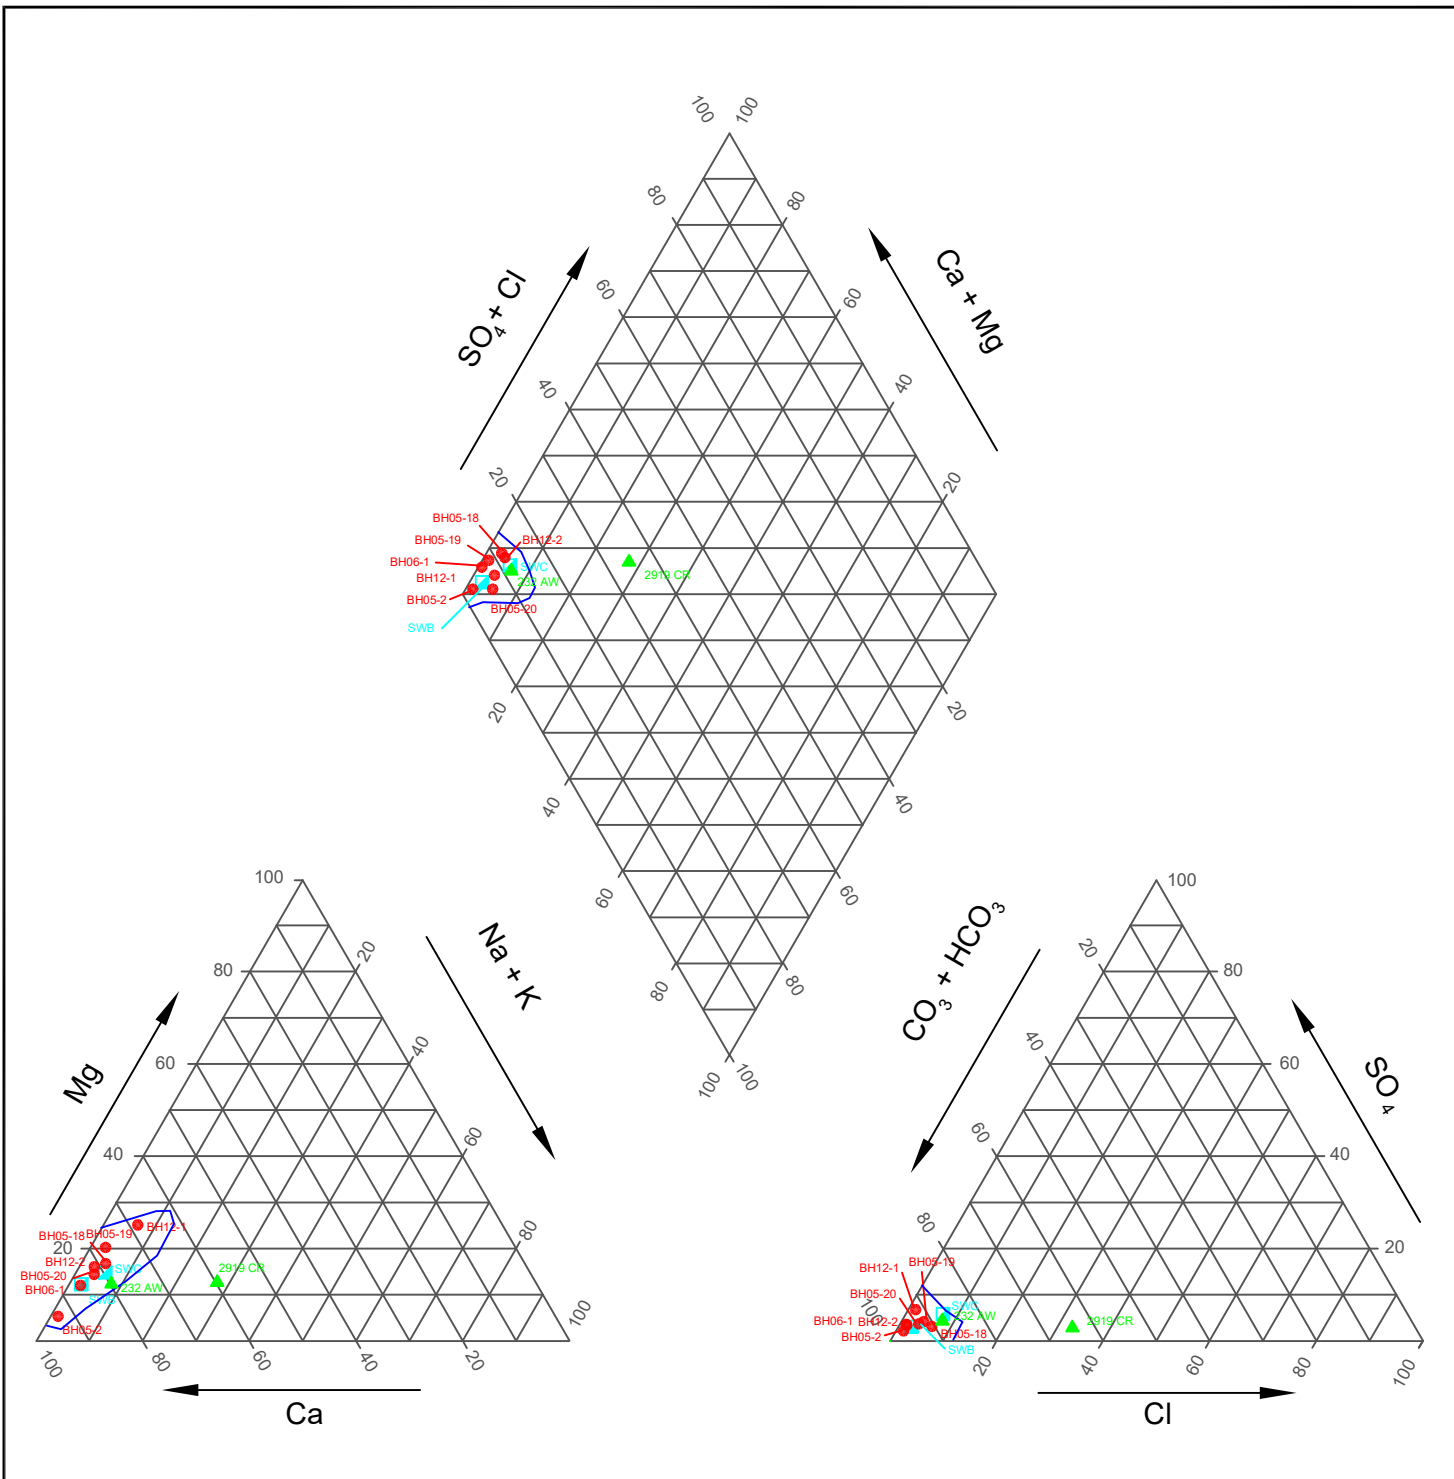
Groundwater Trigger Concentrations were established based on major ions as presented in the Trilinear diagram of Figure 2, as well as based on the Ontario Drinking Water Standards, Objectives, and Guidelines (2006) (ODWSOG) that are included in the chemical summary tables of Tables C-1 through C-6, Appendix C. Major ions include parameters that constitute a major proportion of the water quality, and include: alkalinity, chloride, sulphate, calcium, magnesium, potassium, and sodium.

The Trilinear diagram shows that groundwater obtained from the onsite monitoring wells and the residential water wells in 2016 is similar and plots in a similar location to baseline conditions on the diagram. A notable change in groundwater quality will result in a shift in the plotted location of a monitoring well or residential water well on the diagram. For example, [REDACTED].

The Trilinear diagrams show that the surface water quality is similar, and is similar to groundwater quality, except at station FH-SW1, which shows a slightly greater chloride and sulphate composition. A notable change in surface water quality will result in a shift in the plotted location of a station on the diagram.

Surface Water Trigger Concentrations were established based on major ions as presented in the Trilinear diagrams of Figure 2, as well as based on the Provincial Water Quality Objectives (1994 plus updates) (PWQO) that are included in the chemical summary tables of Tables D-1 and D-2, Appendix D.
